NASA CR-120888
Contract NAS3-12023

Final
Report

Composite Overwrapped Metallic Tanks

MARTIN MARIETTA CORPORATION

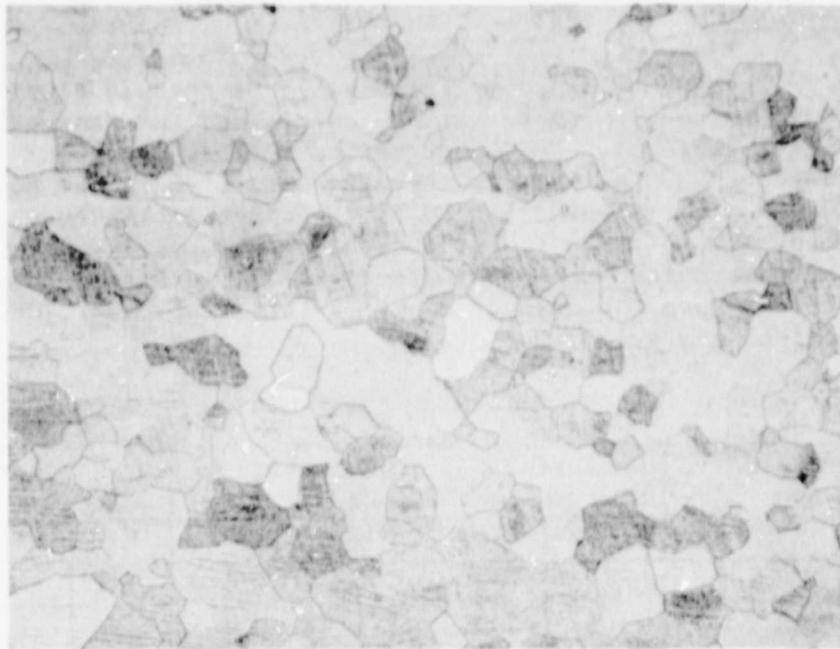
A metallurgical investigation as to the cause of failures was then undertaken. The normal cause for forming failures in titanium (a hard face-oxidized surface and contamination) was suspect. Investigation revealed that improper annealing by the producer rather than contamination was the cause. Mill records were studied and it was determined that one group of the plates had been annealed at 1500°F for 30 minutes and the second group at 1500°F for 15 minutes. While normal tensile tests did not reveal the lack of a proper anneal, the photomicrographs left no doubt as to the material condition. Photomicrographs (Fig. 7 and 8) show the heavily textured grain structure with no indication of alpha surface scale. All the formed domes listed in Tables 1 and 2 exhibited crosshatched microcracks (Fig. 9). The crosshatched microstructure automatically scrapped all domes that had been produced to this point even though they did not indicate conditions of surface cracking. The normal equiaxial grain structure for this alloy is shown in Figure 10.

Figure 10 Photomicrograph of Properly Annealed
Ti-5Al-2.5Sn (ELI)

Attempts to return the material to the producers were fruitless and, since replacement appeared out of the question, it was determined that a proper annealing cycle must be developed to salvage the remaining material. This was accomplished, and a period of four hours at 1650°F in a vacuum followed by a furnace-cool proved to be the optimum cycle. The full report of the failure analysis and supporting technical data may be found in the appendix. The ABAR vacuum furnace at the Denver Division facility was not large enough to economically anneal the blanks. The only other suitable, certified vacuum furnace in the area was located some 60 miles away in Colorado Springs at the Proto Shop. This furnace, an Ipsen, contained automatic controls, proper temperature and pressure read-outs, and recording equipment. After thoroughly discussing the problem, arrangements were made with the very cooperative Proto Shop management to give the titanium annealing effort first priority. A maximum effort to properly anneal the material for explosive forming and to provide "in process" annealing between shots was undertaken. The annealing for the remaining supply of blanks began on April 23 and was completed on May 23. In the meantime, blanks were being given their first explosive-forming shots, process annealing, and second shots, etc, as rapidly as

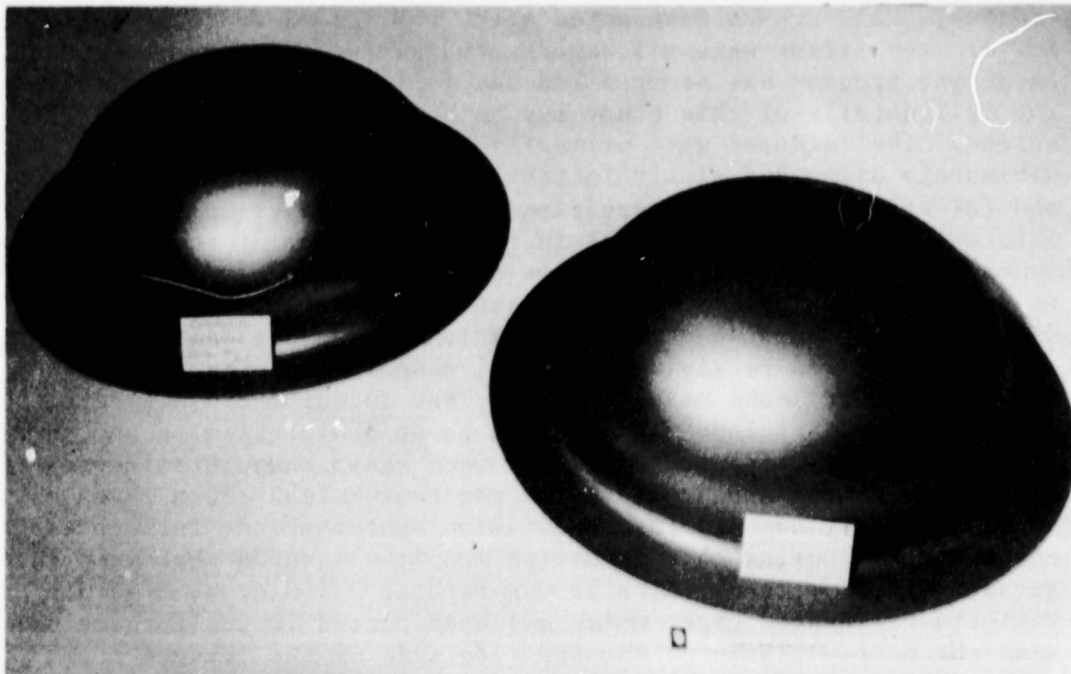
In general, before and after each dome-forming operation, the dome had to be annealed. The dome was prepared for annealing by chem milling 0.005 inch maximum per surface and coating with Turco Pretreat (Fig. 12) to prevent oxidation. After annealing, the Turco Pretreat was removed by again chem milling the dome. This processing sequence proved successful and no further dome cracking was experienced.

Figure 12 Fully Formed Domes Coated with Turco Pretreat Prior to Annealing in Air Furnace

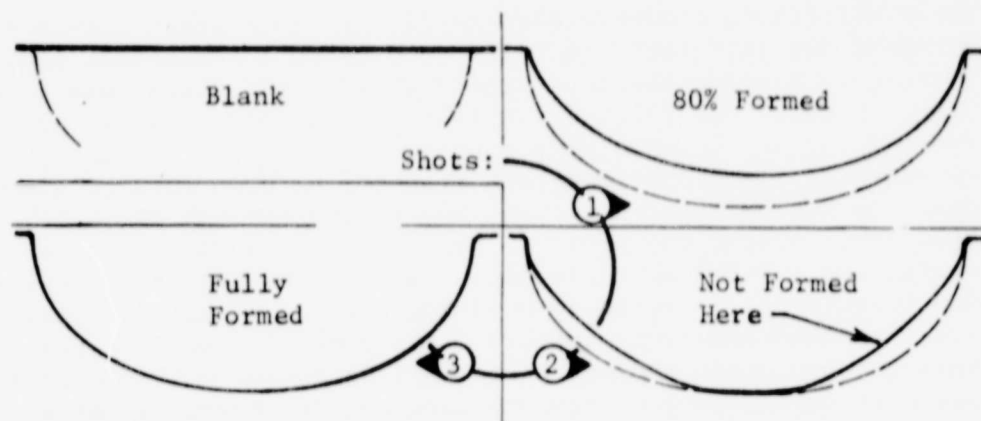
Raw Material Thickness Deviation: $0.220 \begin{matrix} +0.046 \\ -0.010 \end{matrix}$ in.

Best Deviation from Contour (H-2): $-0.030, +0.050$ in.

Figure 17 Explosive-Forming Sequence

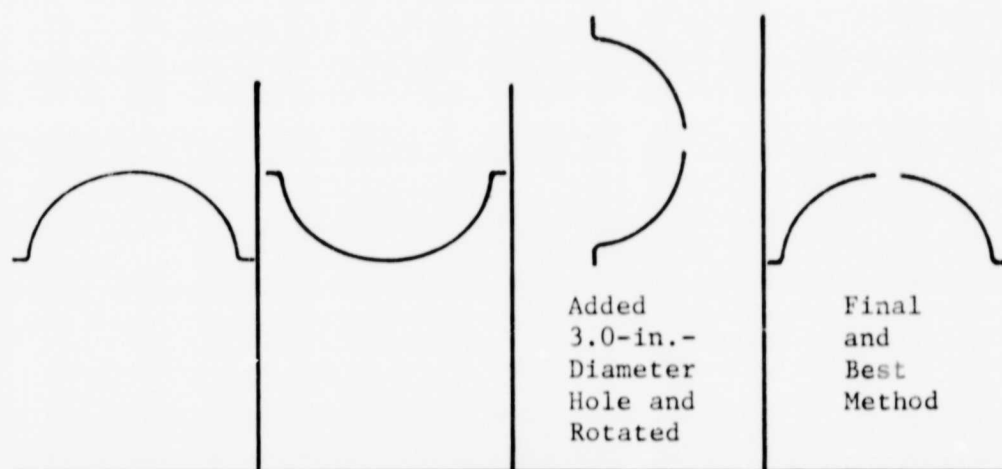
Early efforts to optimize chem-milling methods began with a fixture designed and fabricated to hold the dome in a horizontal position. Nonuniform etching was experienced whether the flange was up or down. Discussions pointed out that gas entrapment areas along the contour and at the apex were causing preferential etching. The recommended fix was to create a hole at the dome apex to allow gases to flow along the contour and escape through the hole. This apparently solved the problem, but after a manufacturing personnel change and another schedule delay, an alternative method was tried. The fixture was modified to hold the dome in a vertical position and it became necessary to rotate the dome at closely timed intervals to once again prevent preferential etching. This approach met with fairly good success as long as the chem-mill operator closely controlled the rotation intervals. Although some success was experienced, the process was later revised to holding the dome in the horizontal position. This method was more reliable and produced the best results. Figure 2 shows the dome chem-mill pattern desired and Table 5 reflects a typical actual thickness and contour chart for a single dome. Dome E2 reflected the best chem-mill results with 0.109/0.122 inch in the thin area and 0.154/0.164 inch in the thick area. The worst dome was N1, which had 0.109/0.144 inch in the thin area with 0.127/0.188 inch in the thick area. Figure 18 depicts sequential dome positions developed for best chem-milling results. Figures 19, 20, 21, and 22 illustrate the chemical milling process.

Thickness Deviation after Chem-Mill:

$$\text{Best (E-2)} = \frac{0.109}{0.122} \text{ \& } \frac{0.154}{0.164} \quad \text{Worst (N-1)} = \frac{0.109}{0.144} \text{ \& } \frac{0.127}{0.188}$$

Figure 18 Development of Dome Position in Chem-Mill Tank

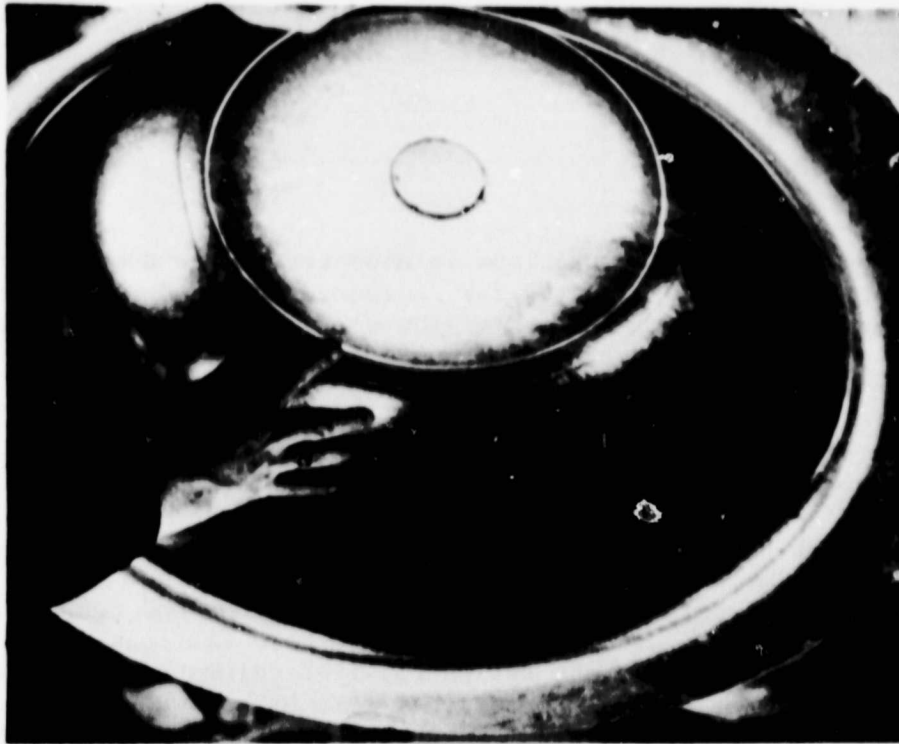
Figure 21 Dome Interior Showing Chem-Mill Steps

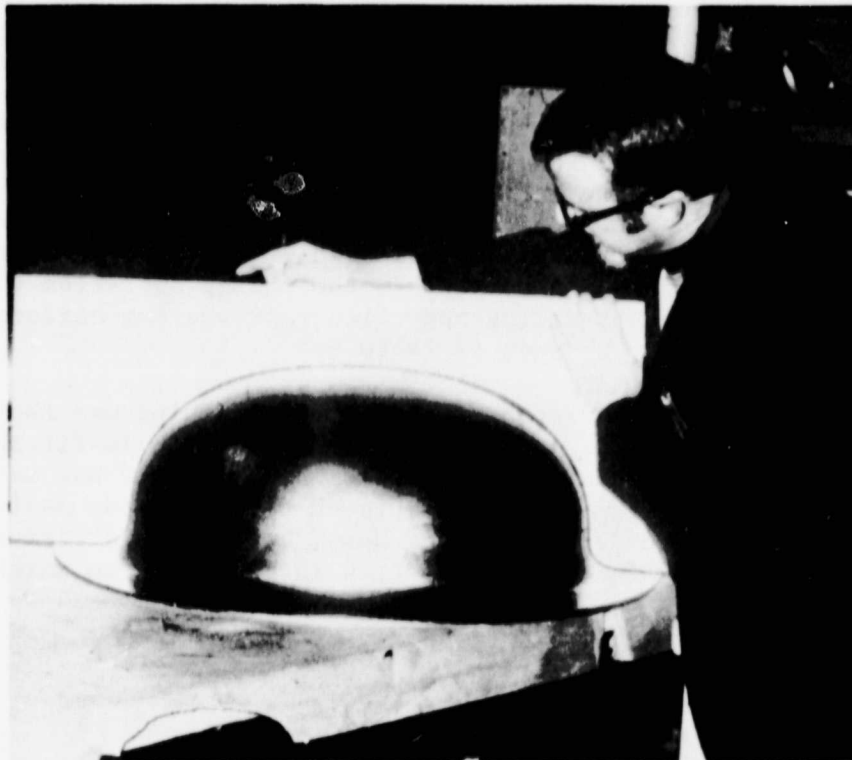
Figure 22 Project Engineer Noting Contour Deviation of Dome with External Contour Template

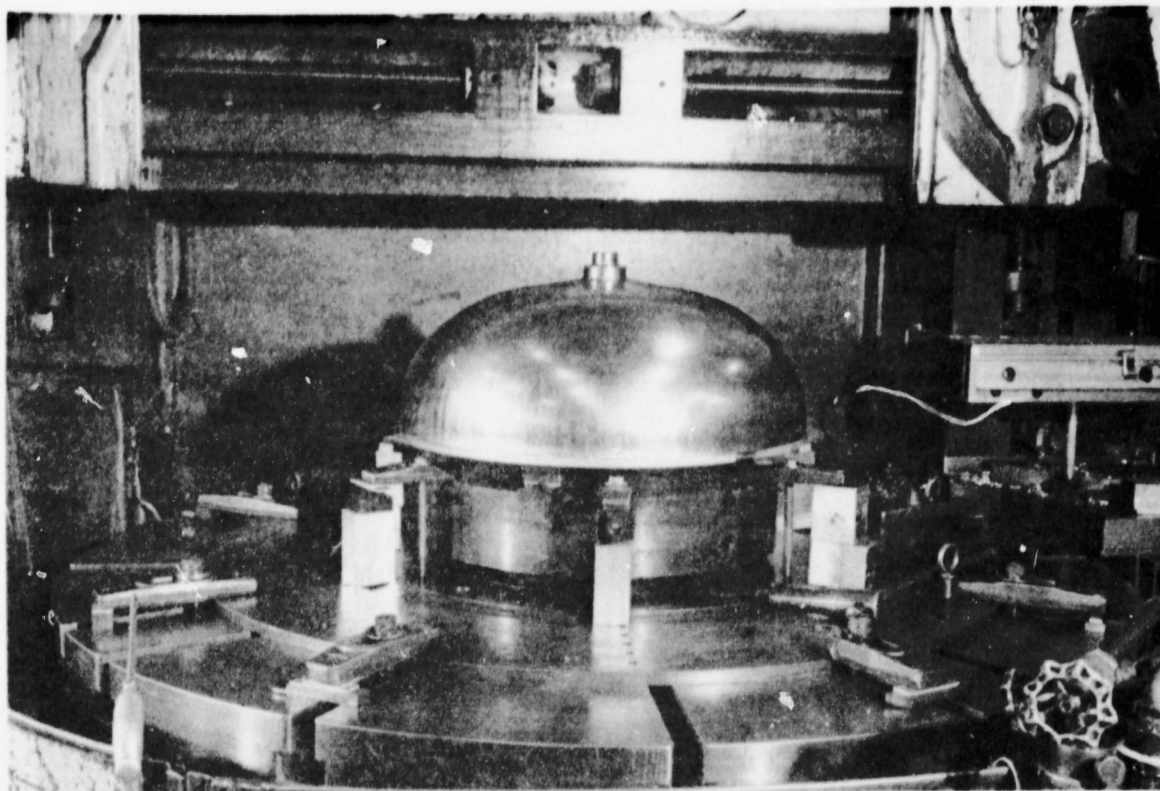
Figure 26 Dome Subassembly Shown in Holding Fixture for Machining Final Outside Diameter to Eliminate "Bell Mouthing"

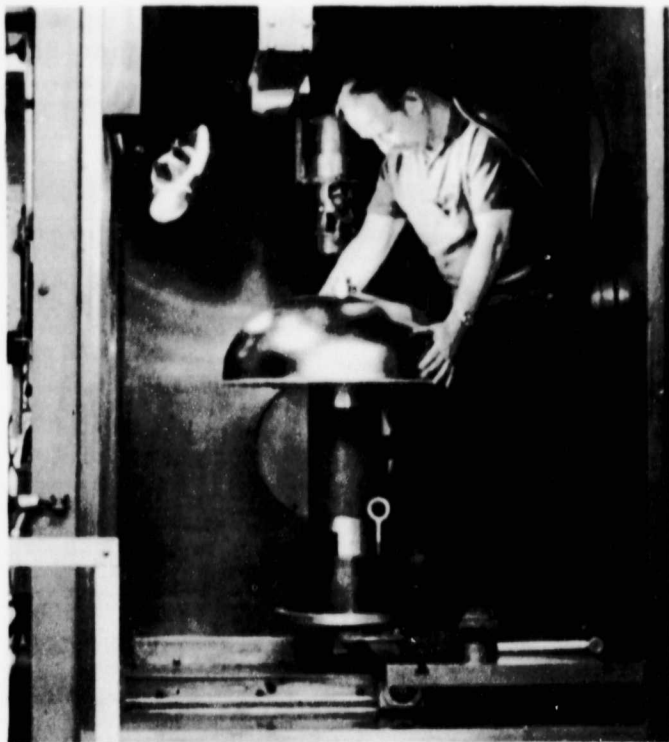
The only minor problem in joining this subassembly was caused by the domes springing out of shape after machining the hole from the dome apex. To correct the problem, the weld fixture was reworked to force alignment of the dome contour to the fitting contour prior to welding.

Figure 32 Electron Beam Weld Technician
in Weld Chamber Assembling
Dome and End Fitting on Fixture
for Welding

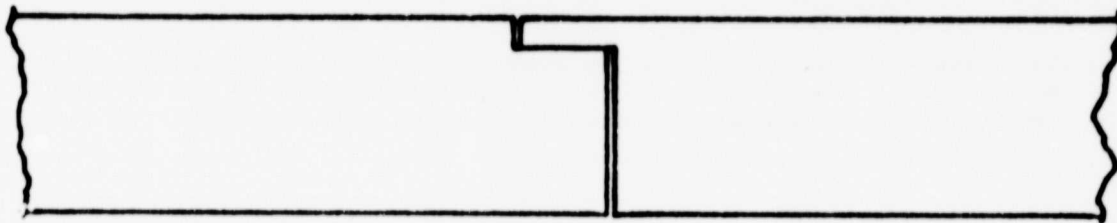
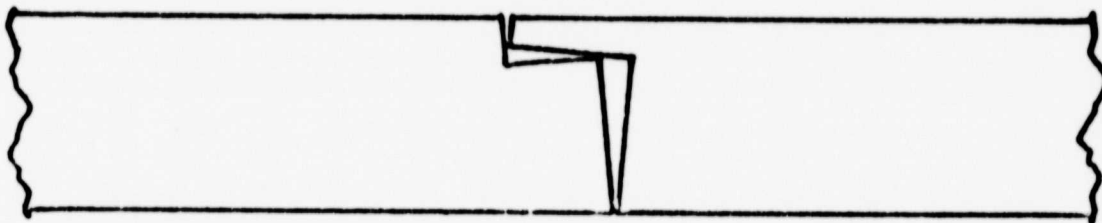
Figure 33 Interlocking Joint Concept

After selecting two matched dome subassemblies, a barrel was rolled, trimmed to fit, and machined for welding. Because there was no provision for access to the final tank closure weld, internal tooling could not be used. The design was therefore engineered to provide an interlocking step joint at the dome-to-barrel interface. This idea was employed to replace the normal weld backup tooling concept. As anticipated, fitup problems occurred (Fig. 33). After S/N 1 failed because of lack of fusion in this joint, a butt joint was determined necessary to eliminate fit and, hopefully, lack of fusion problems. Although the butt joint presented no machining or fit problems, it became necessary to TIG-tack the assembly at about 4-inch intervals around the circumference to hold it together prior to electron beam welding. Slight but acceptable porosity and tungsten inclusion difficulties appeared on X-rays from the TIG tacking (Fig. 34).

As-Assembled Joint

(Poor Fitup due to Machining Tolerances and Dome Out-of-Roundness)

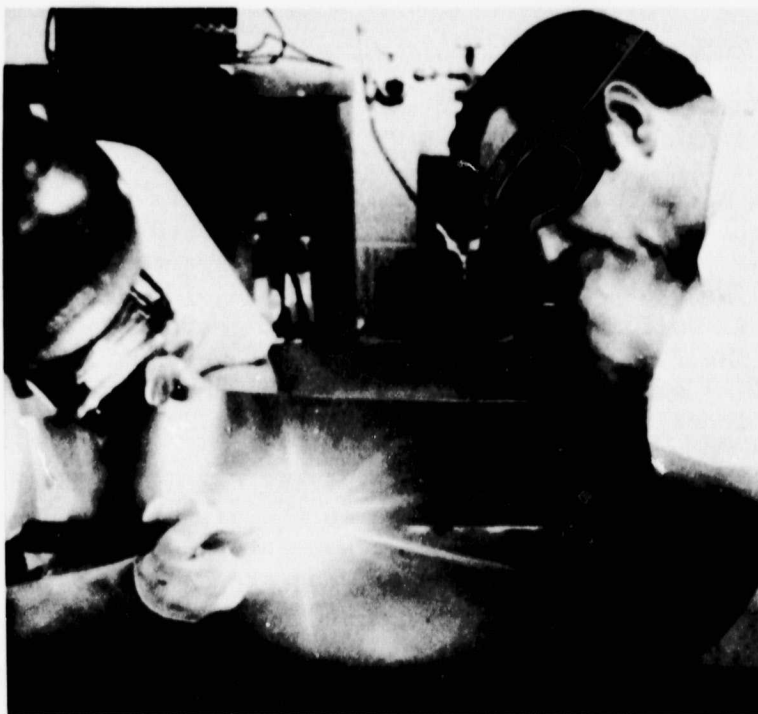
Figure 34 TIG Surface-Tack Weld of Barrel-to-Dome
Prior to Performing Electron Beam Weld

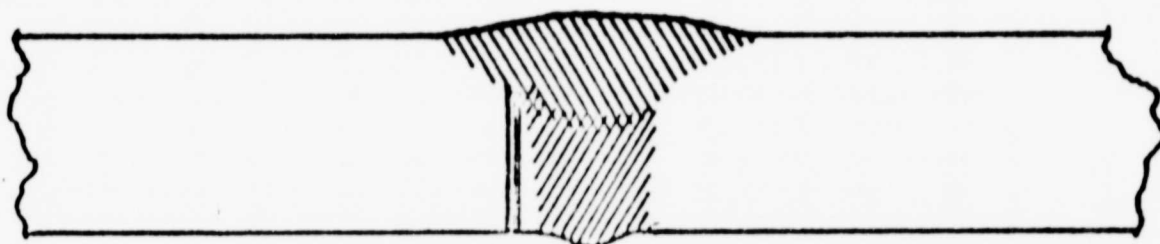
Having seemingly solved the lack of fusion problem by going to the better fitting butt joint, S/N 2 was welded and returned from Baltimore to Denver where it was overwrapped and sizing was begun. S/N 2, however, again failed in one of the girth joints and again due to lack of fusion. Three areas of effort were initiated to solve the problem. The holding fixture in the electron beam welder was dismantled and reworked to give a more accurate alignment. The X-ray technique was investigated and several improvements were made to upgrade the confidence level of detecting lack of fusion. To improve the quality of the weld itself, a study of the effect of multiple-pass welds was initiated. This program involved three panels that were welded using a single-pass, a double-pass, and a triple-pass weld bead. Tensile specimens were then removed from each panel and tested to determine the effect, if any, on the strength and quality of the joint. The results are shown in Table 7.

Figure 35 illustrates the lack of fusion on S/N 2 when the single-pass weld technique simply missed the joint. The only thing holding the joint together was the cosmetic pass over the outside for smoothing out the contour. The lower portion of Figure 35 illustrates how the triple-pass weld technique would solve any misalignment encountered. Due to the acceptable results of the tensile tests, the remaining tank liners were joined at the girth with three parallel adjacent welds. No further lack of fusion problems occurred in the girth joints.

Electron Beam Weld Off ϕ of Joint

Figure 35 Defective Single-Pass Electron Beam Weld and Proper Triple-Pass Weld

Triple Pass Plus Cosmetic Pass

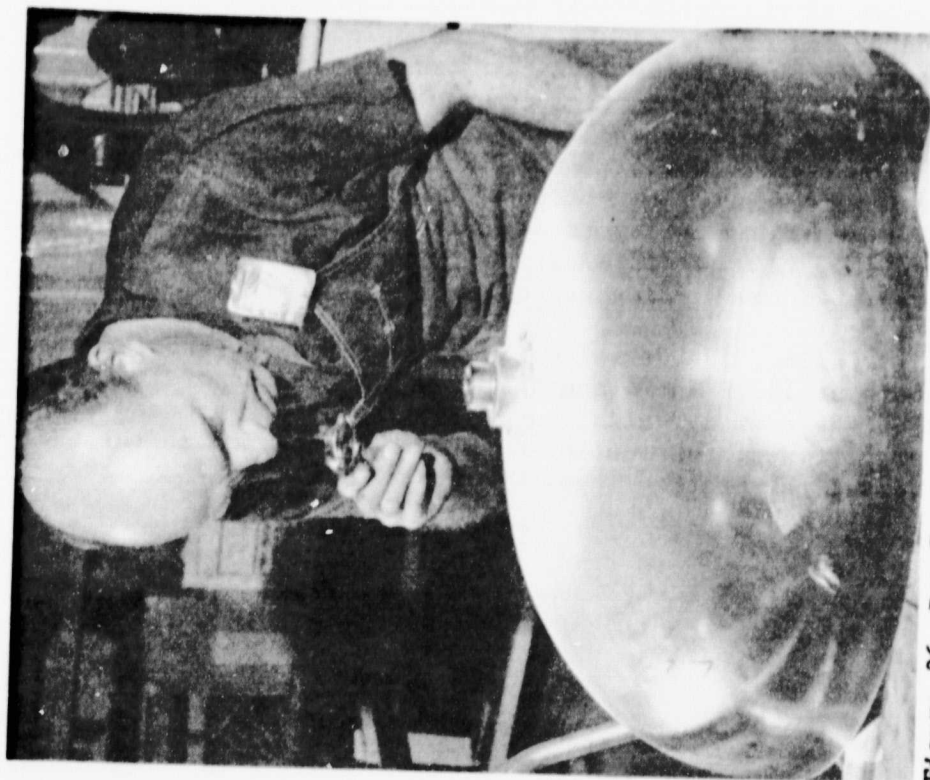
Normal inspection and acceptance tests of welded tankage were conducted for this program. Each weld for each subassembly and the final closure weld were dye-checked and X-rayed for quality verification (Fig. 36, 37, and 38). After the X-raying and any weld repairs required were completed, the tank liner was subjected to a proof pressure test of 30 psig. The tank liner was then thoroughly dried and a 24-hour helium leak test was conducted. Every tank liner passed all acceptance tests the first time as recorded in the tank processing logs.

Figure 36 Dye-Penetrant Inspector Checking
Dome-to-End Fitting Weld for Quality
Acceptance

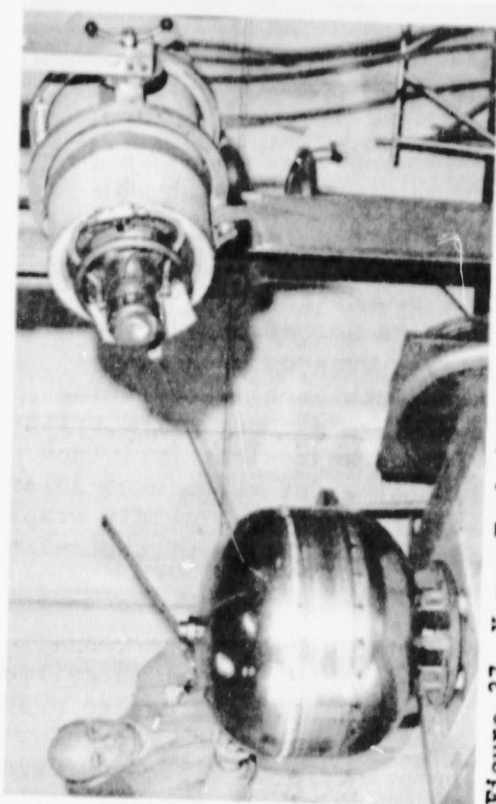
Figure 37 X-ray Technician Aligning X-ray
Machine for Shooting Double-Wall
X-ray on Section of Dome-to-
Barrel Weldment

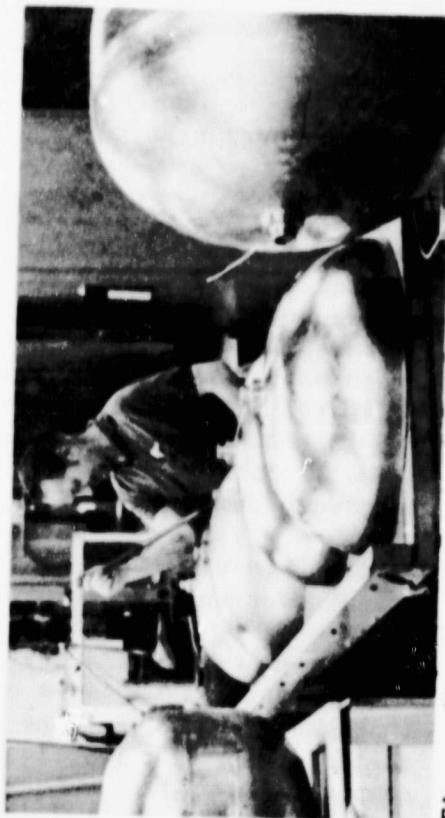
Figure 38 Dome Subassemblies and Completed Tanks
Being Visually Inspected by Electron
Beam Weld Technician

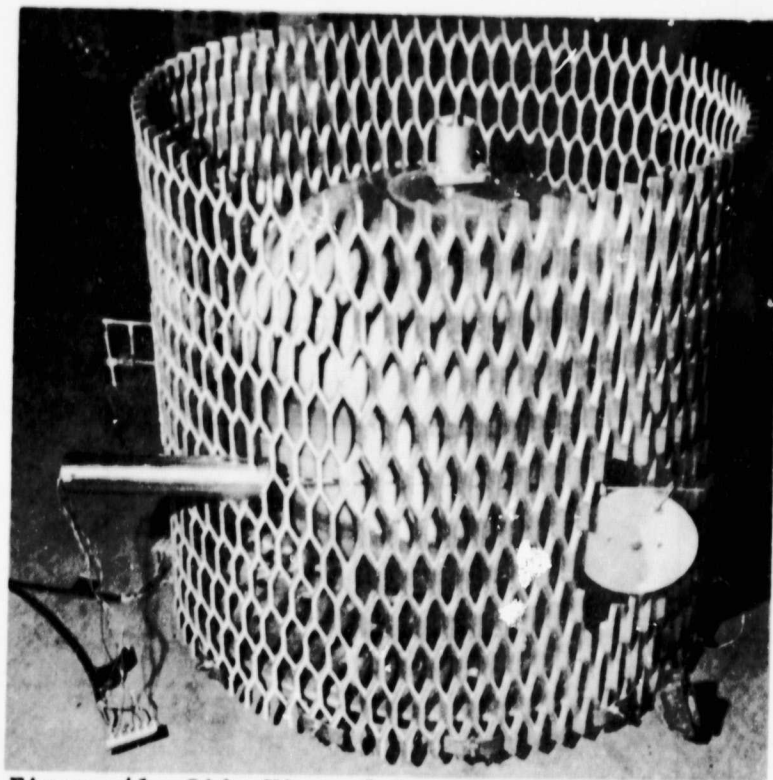
Figure 41 Side View of Overwrapped Test Tank
Showing Hoop Strain Displacement
Instrumentation

All tanks were instrumented with LVDTs (linear variable displacement transformers) in both the hoop and longitudinal directions on the tank (Fig. 41 and 42). In addition, hoop and longitudinal strain gages were mounted on S/N 5 and 8. This was done as an experiment to determine if the LVDTs mounted on the standoffs on the tank and the strain gages cemented to the fiberglass tank surface would read out comparable strains. In both cases, it was determined that the strain gages transmitted good strain correlation with the predicted strains from the computer but not with the LVDTs (see discussion in following paragraph).

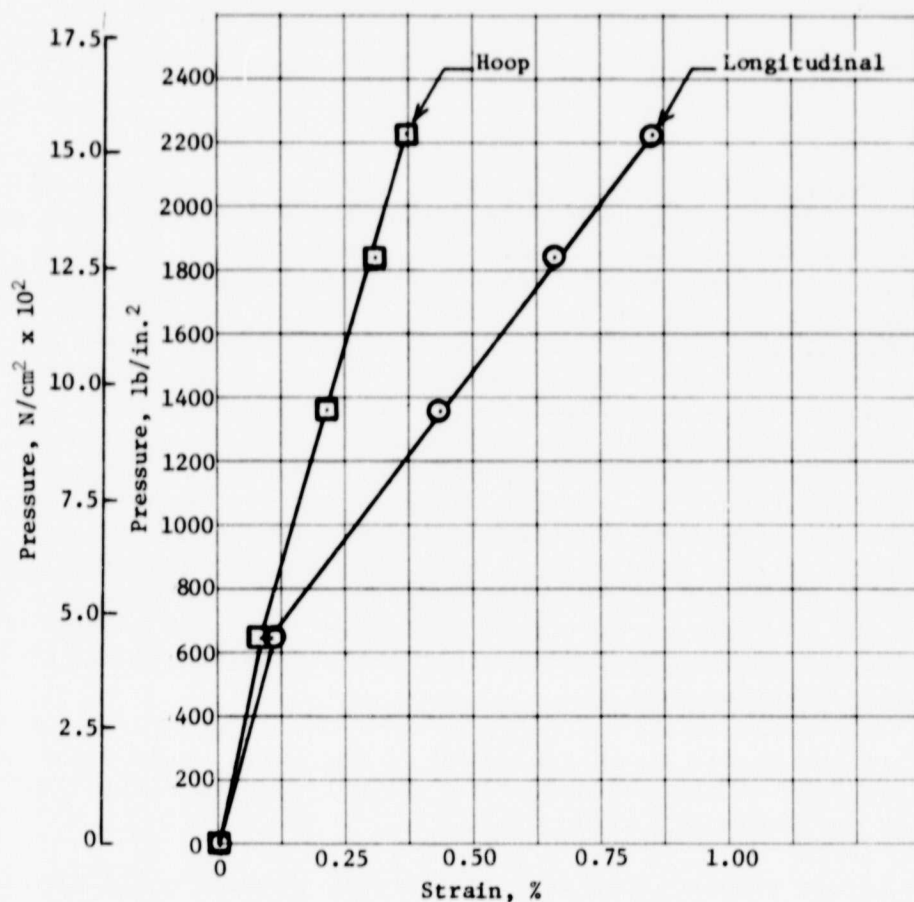
Figure 43 S/N 1 Sizing Test

Figures 43 through 47, 49, 51, and 53 illustrate the strain curves generated by plotting LVDT test data during the sizing operation on each tank. Figures 48 and 54 complement Figures 47 and 53, respectively, with regard to data taken from the sizing operation. Strain gages were mounted on S/N 5 and 8 to verify LVDT accuracies. As can be noted, the hoop LVDT and the hoop strain gage data successfully complement each other. However, the longitudinal LVDT and the longitudinal strain gage data do not complement each other. It is concluded that the longitudinal LVDTs on all tanks did not function properly for unexplainable reasons. To support this conclusion, Figure 55, which plots pressure versus strain as predicted by the computer, has been included. This curve shows a generally equal strain condition in both the hoop and longitudinal directions as it should per the design criteria of this program. Figures 48 and 54, the strain curves generated from strain gage data, verify the desired condition and therefore negate all LVDT longitudinal curves as plotted.

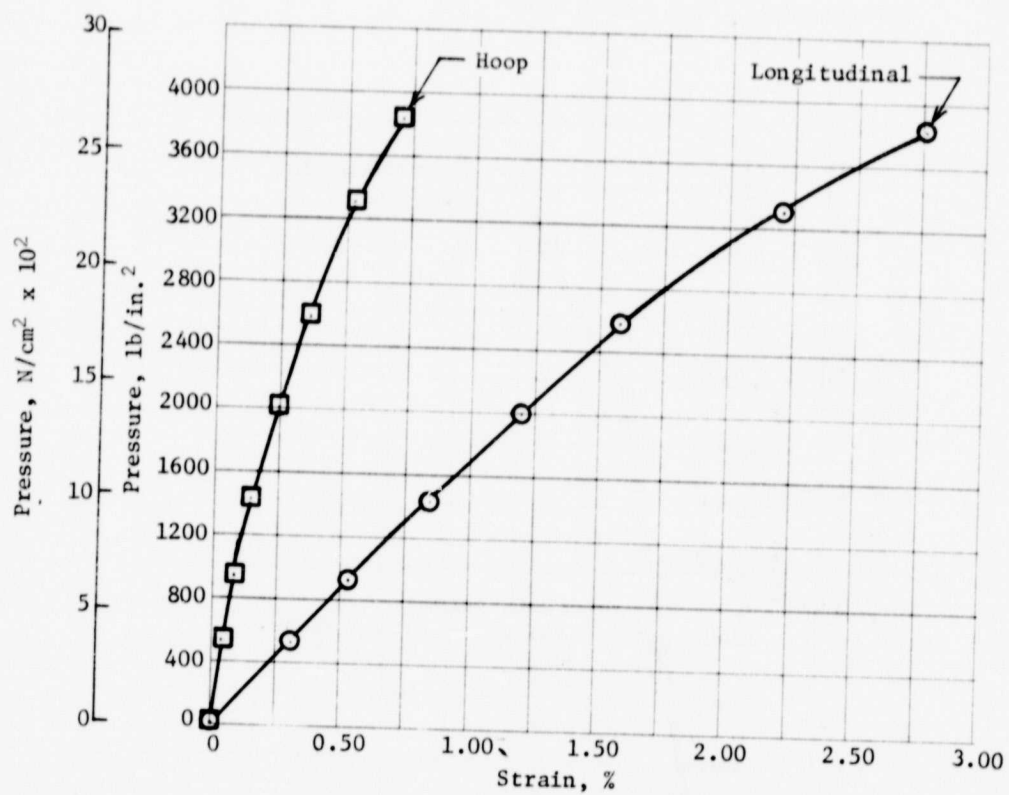
Figure 46 S/N 4 Sizing Test

S/N 4 burst at 3854 psi during the hydrostatic sizing operation. This was the first tank that failed outside the girth weld. In this case, the failure was initiated at the dome-to-fitting joint (Fig. 60). The cause of failure appeared to be a combination of a lack of ductility (Fig. 61 and 62) and joint mismatch. The mismatch was not a typical joint misalignment, but appeared to be a condition referred to as "sink-in" brought about as the dome-to-fitting joint shrunk under pressure while cooling after the weldment had been completed. A fix for correcting the "sink-in" effect utilizing hot forming is shown in Figure 63. Refer to Table 12 for the forming process.

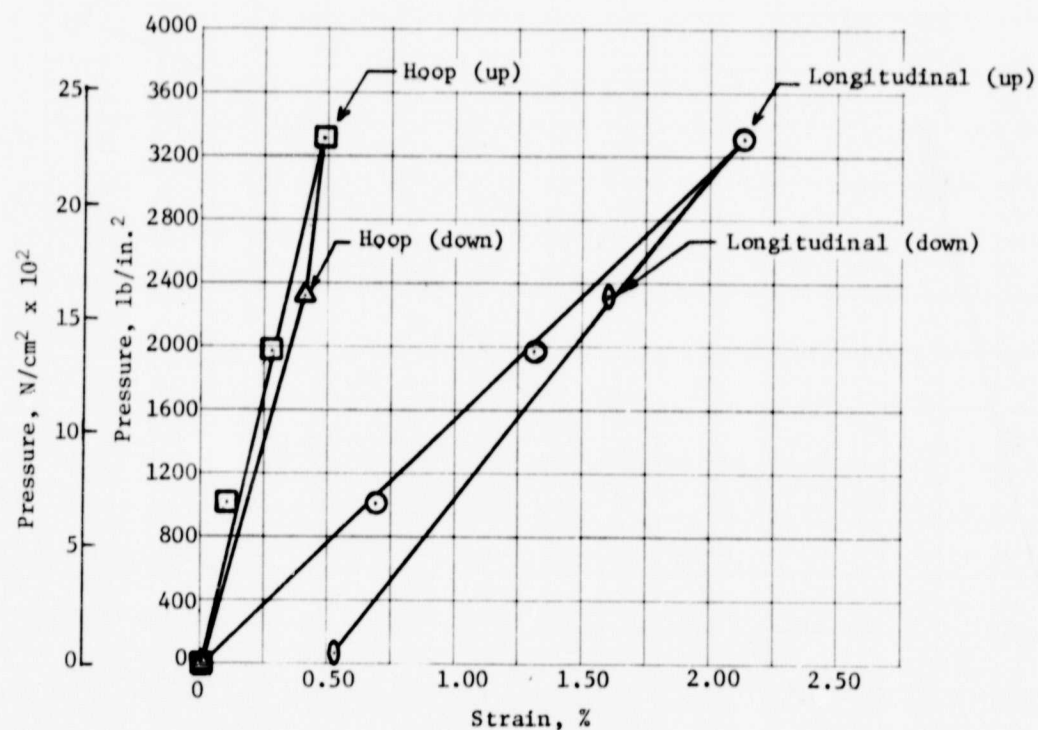
Figure 50 S/N 6 Cycling Test (First Cycle)

Figure 50 is the strain curve generated in the first cycle pressure test of S/N 6. Succeeding cycles are not plotted since they essentially duplicate the first cycle.

*S/N 6 was sized at 4527 psig. Following the sizing operation, the tank was cycled at ambient temperature from 100 psig to 3360 psig. During the 49th cycle, S/N 6 failed at 3350 psig. A pressure decay rate of 21 psig/sec confirmed tank failure during the attempted 50th cycle.

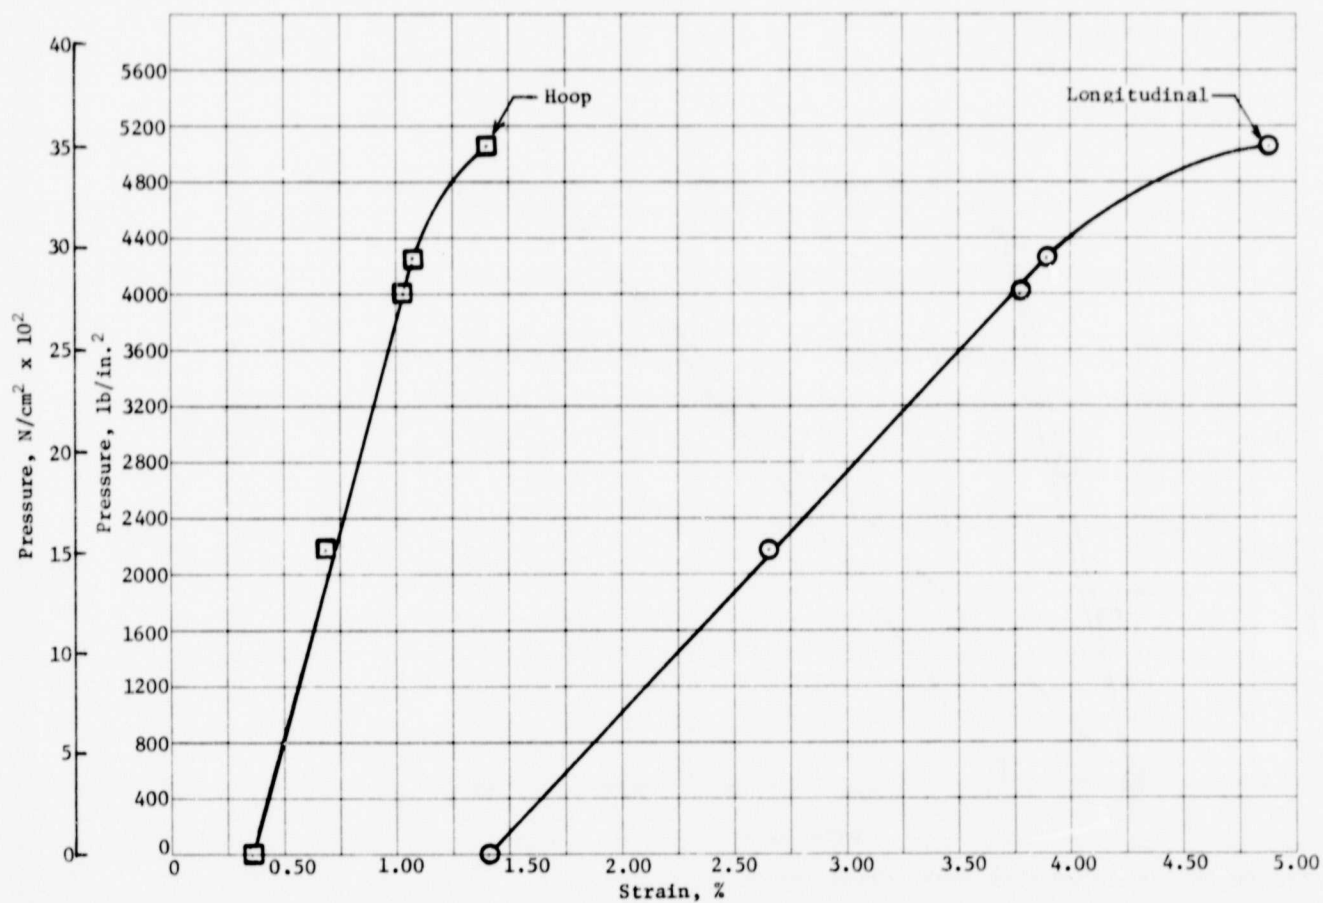
Figure 52 S/N 7 Burst Test

Figure 52 is the strain curve generated during ambient burst test of S/N 7. It is interesting as well as predictable to note that there are residual strains in S/N 7 after it was sized and depressurized. No attempt has been initiated to draw any conclusions from these data because S/N 7 was the only tank tested in this manner.

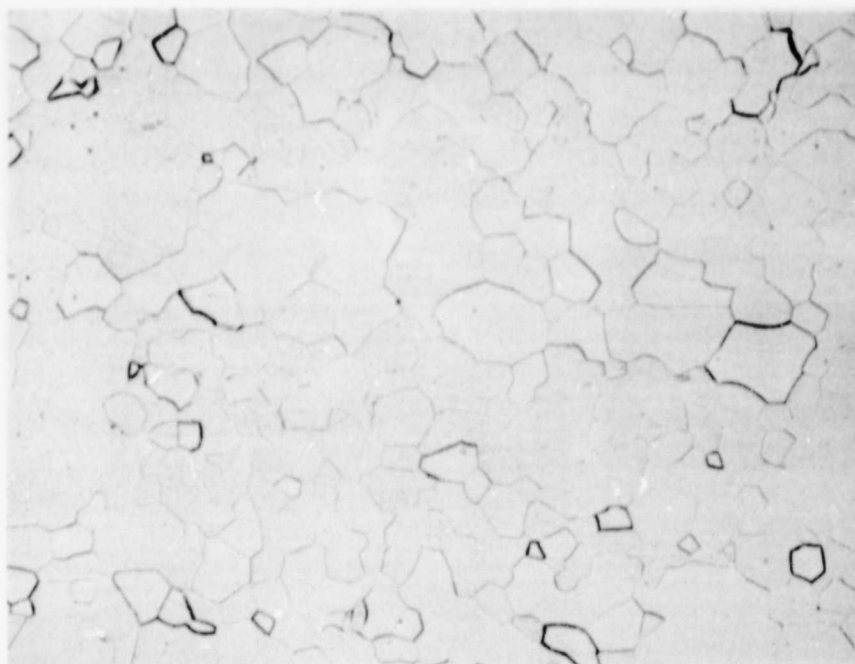
Figure 72 Photomicrograph of Normal "Clean"
Microstructure (100X)

A helium leak check revealed the leak to be in the parent material (Fig. 68 and 69). Dissection of the specimen at the failure point indicates the possibility of stress corrosion (Fig. 70 and 71). In addition, the microstructure near the failure point appears to have a grain boundary precipitant typical of overannealing or overheating. Figures 72 and 73 show comparisons of normal "clean" microstructure versus the "dirty" microstructure near the failure point.

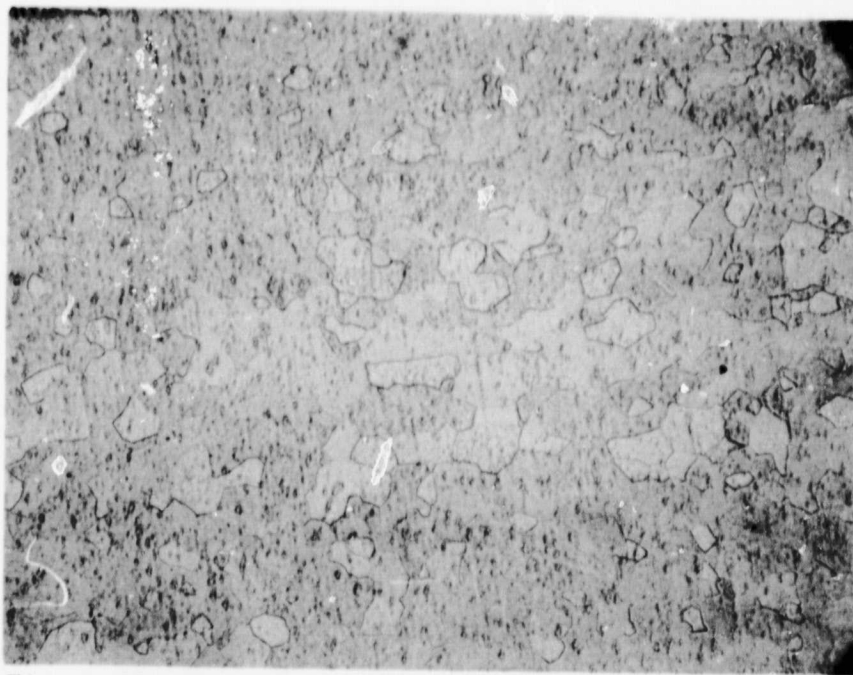
Figure 10 Photomicrograph of Longitudinal Cross
Section at 100X of C Plate Annealed
1 hour at 1660°F

Temperature, °F	F _{tu} , ksi	F _{ty} , ksi	%e, 2 in.	Micro
1300	126.8	123.3	--	Fig. 4
1400	125.6	121.7	14.8	Fig. 5
1440	121.0	118.7	--	Fig. 6
1500	121.7	117.6	16.7	Fig. 7
1545	119.9	116.9	17.5	Fig. 8
1600	120.0	116.5	17.3	Fig. 9
1660	117.3	114.3	18.2	Fig. 10

As a result of the 1-hour tests and the 2-hour tests at higher temperature, it was decided that the ductility (F_{ty} and %e) would be best at around 1650°F. Subsequent tests at different times showed the best combination of F_{ty}, %e, and grain structure to be around a 4-hour anneal at 1660°F.

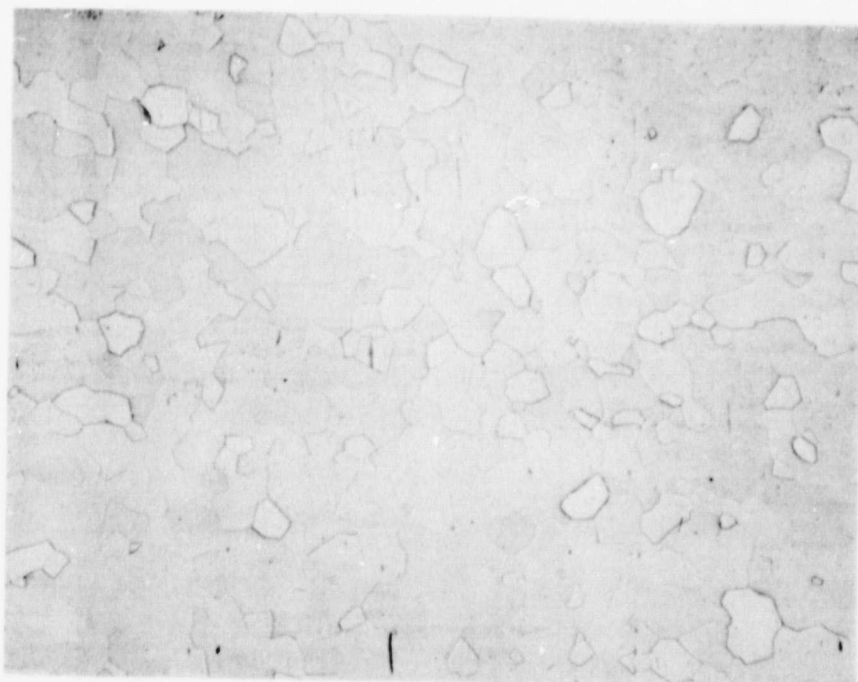
Figure 11 Photomicrograph of Longitudinal Cross
Section at 100X of C Plate Annealed
2 hours at 1700°F

Temperature, °F	F _{tu} , ksi	F _{ty} , ksi	%e, 2 in.	Micro
1700	115.8	113.3	16.9	Fig. 11
1750	116.1	113.4	15.2	Fig. 12

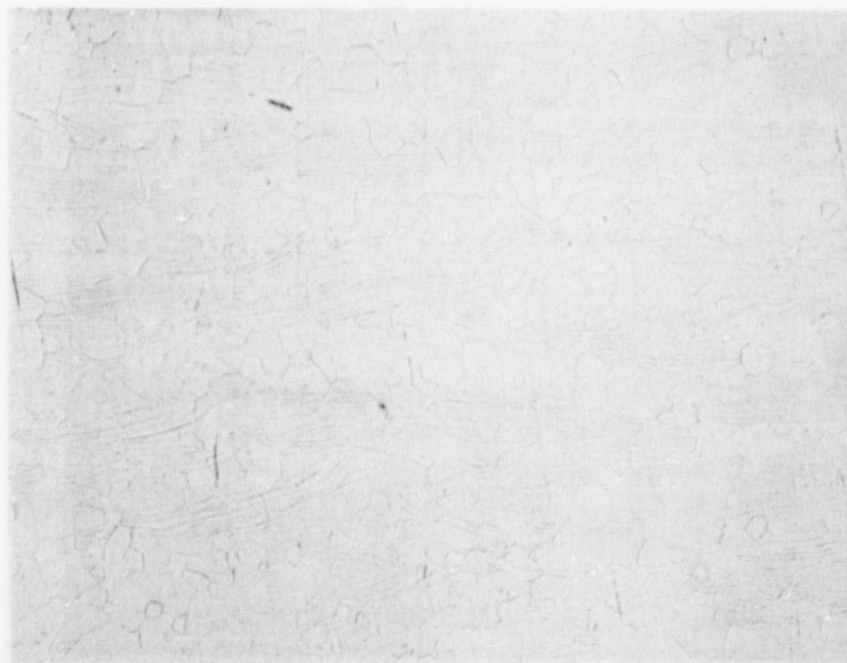
Figure 12 Photomicrograph of Longitudinal Cross
Section at 100X of C Plate Annealed
2 hours at 1750°F

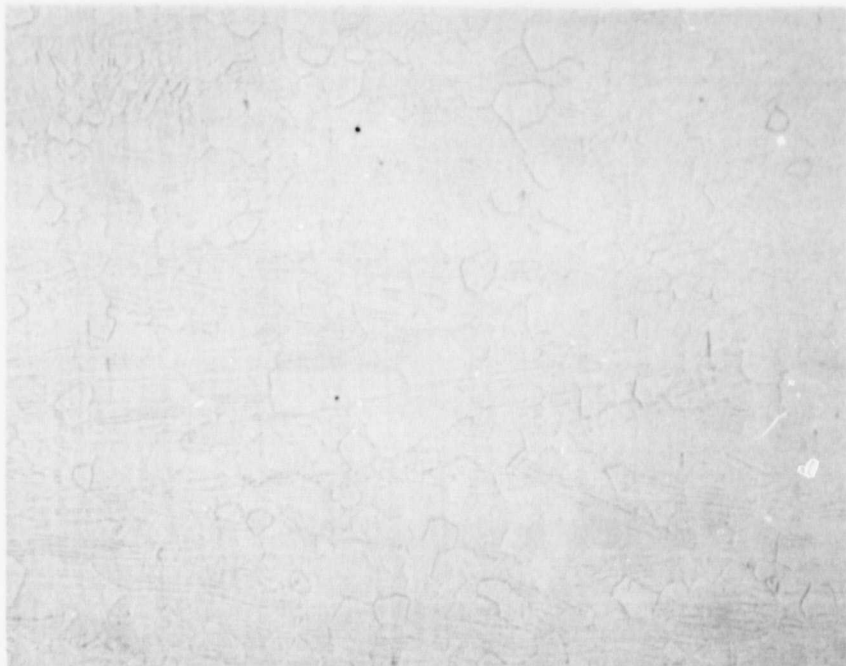
Time, hr	F _{tu} , ksi	F _{ty} , ksi	%e, 2 in.	Micro
1	117.9	114.2	16.3	Fig. 13
2	116.6	114.1	16.8	Fig. 14
4	116.0	114.0	17.5	Fig. 15
8	115.9	113.9	15.0	Fig. 16
24	113.5	110.6	13.5	Fig. 17

Figure 13 Photomicrograph of Longitudinal Cross
Section at 100X of C Plate Annealed
1 hour at 1660°F

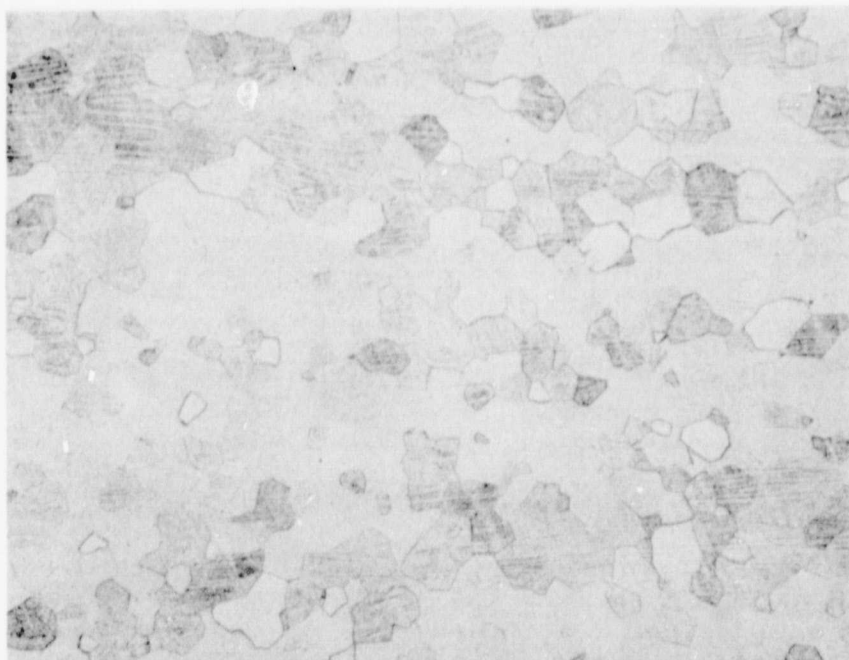
Figure 14 Photomicrograph of Longitudinal Cross
Section at 100X of C Plate Annealed
2 hours at 1660°F

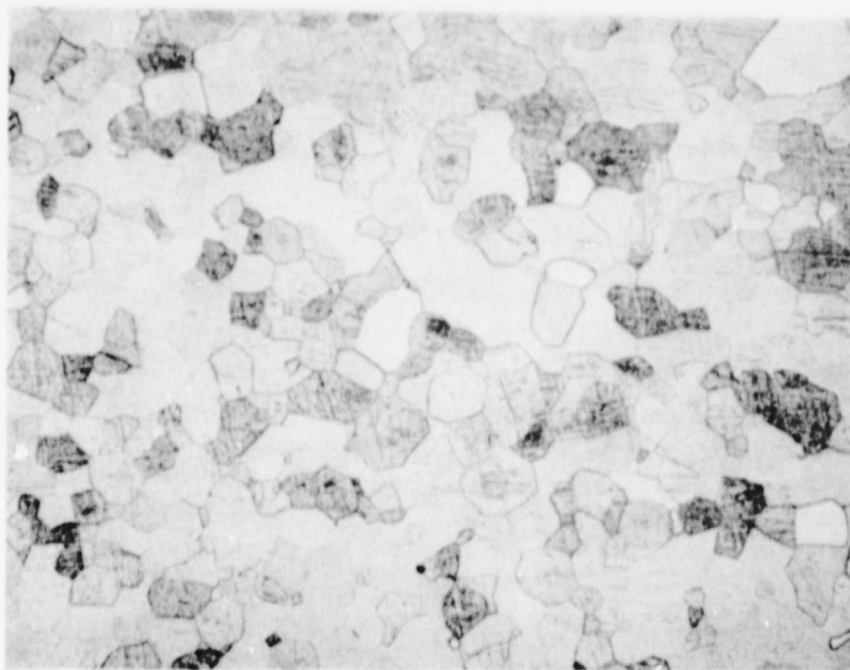
Figure 15 Photomicrograph of Longitudinal Cross
Section at 100X of C Plate Annealed
4 hours at 1660°F

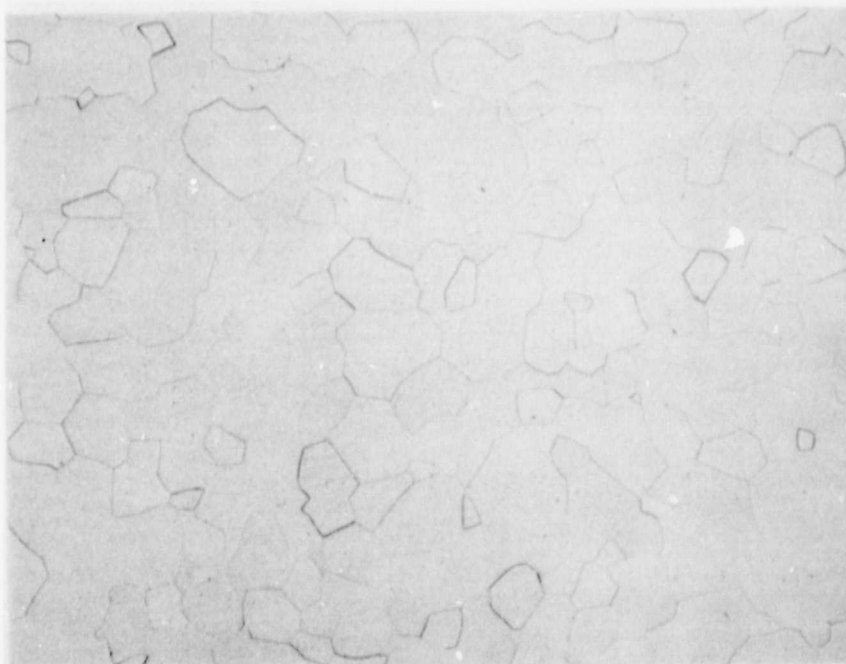
Figure 16 Photomicrograph of Longitudinal Cross
Section at 100X of C Plate Annealed 8
hours at 1660°F
